Forensic Cases

Evidences tell the truth: A Case of Fire

Mukesh Sharma and Manishi Shriwas

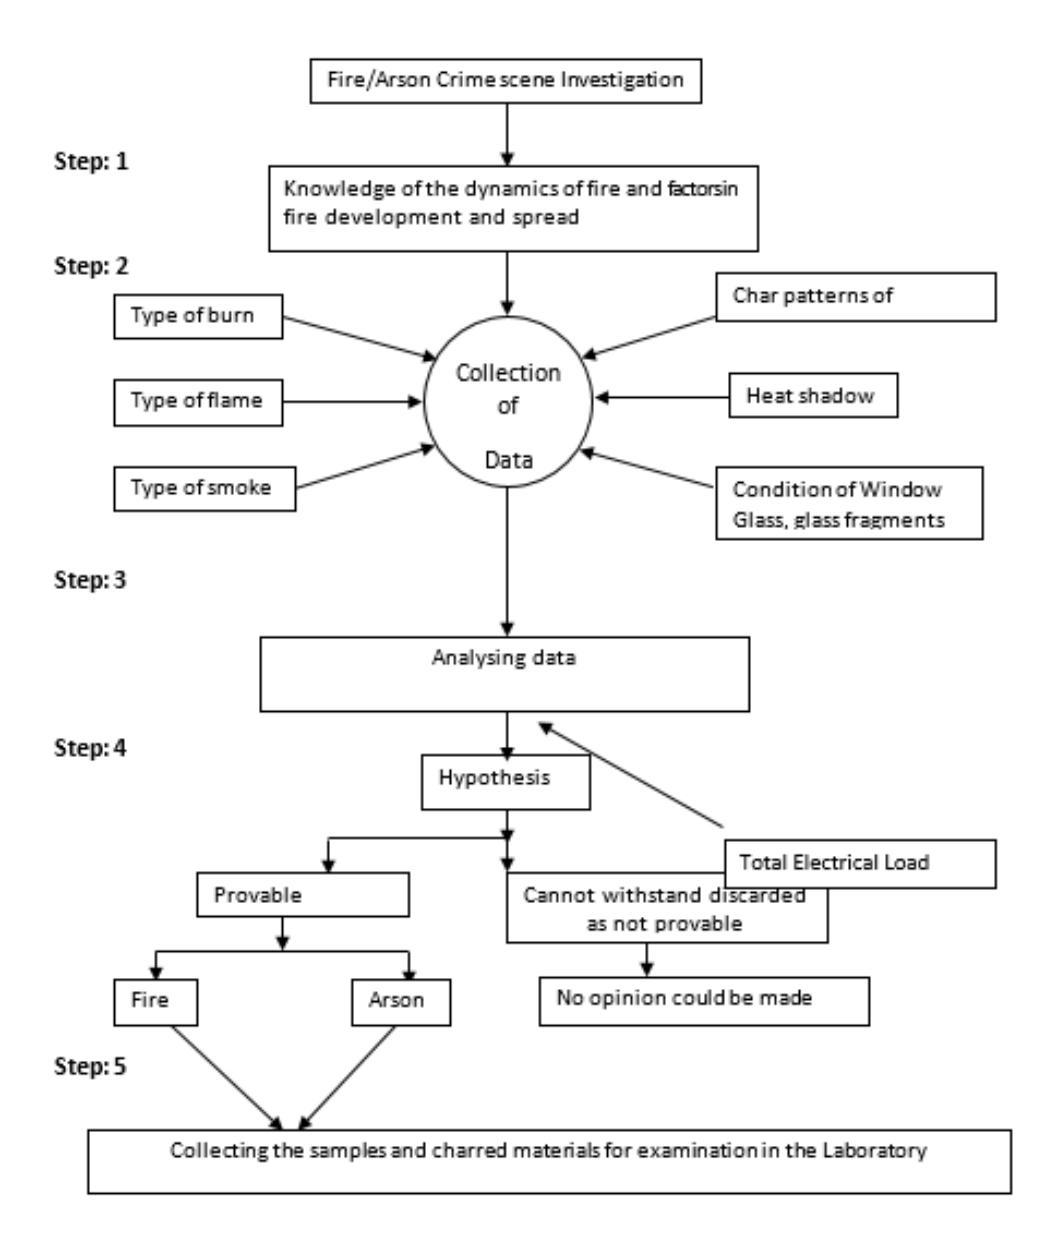
Fig. 1: Flow chart of steps 1 to 5 to analysing a fire/arson investigation

The investigation of fires or arson is an act as well as science. A combination of factual information as well as the analysis of the facts must be accomplished objectively and truthfully. The systematic approach recommended is that of the scientific method used in the physical sciences [3]. In the flow chart shown in Fig. 1 which is a result of thorough study of the reference literature [4-5], is developed for the sack in the help of the investigator to examine the fire crime scene in five steps. From the flow chart it is clearly seen that one should the follow the step during the examination. In STEP 1, one should have the knowledge of dynamics of fire and on which factor the fire development is depend and spread. In STEP 2,

the crime scene investigator (CSI) has to examine the crime scene like char pattern, colour of smoke, colour of flame and residue parts etc. Inductive reasoning with all of the collected and observed information should be done in STEP 3. On the basis of data analysis, CSI should develop a hypothesis to explain the origin and cause of fire and test of the hypothesis in STEPs 4 and 5.

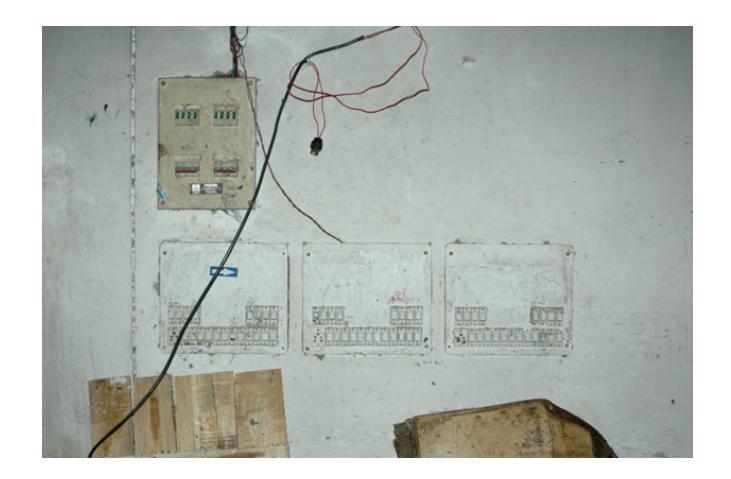
2. The debris of burnt/ partially burnt paper and furniture were floating in the water. The spot was thoroughly searched for cause of fire. The electric distribution board mounted in the wall has many on/off switches which were intact and already in off condition (Photograph 2)

Photograph 2: showing on/off switches which were intact and already in off condition

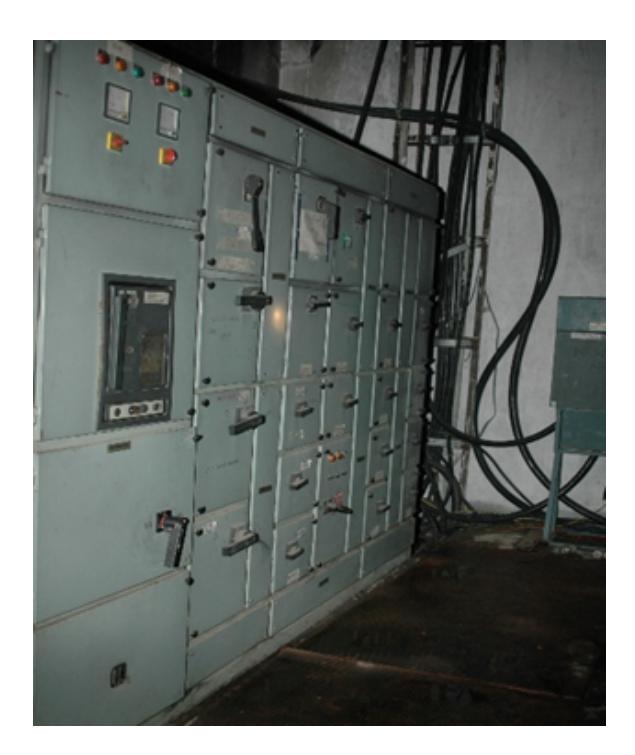
3. The main distribution circuit was intact and there was no sign of sparking. The insulation of the wires and armoured cables were intact with out sign of heat or flow of heavy current (Photograph 3).

Photograph 3: showing distribution circuit were intact

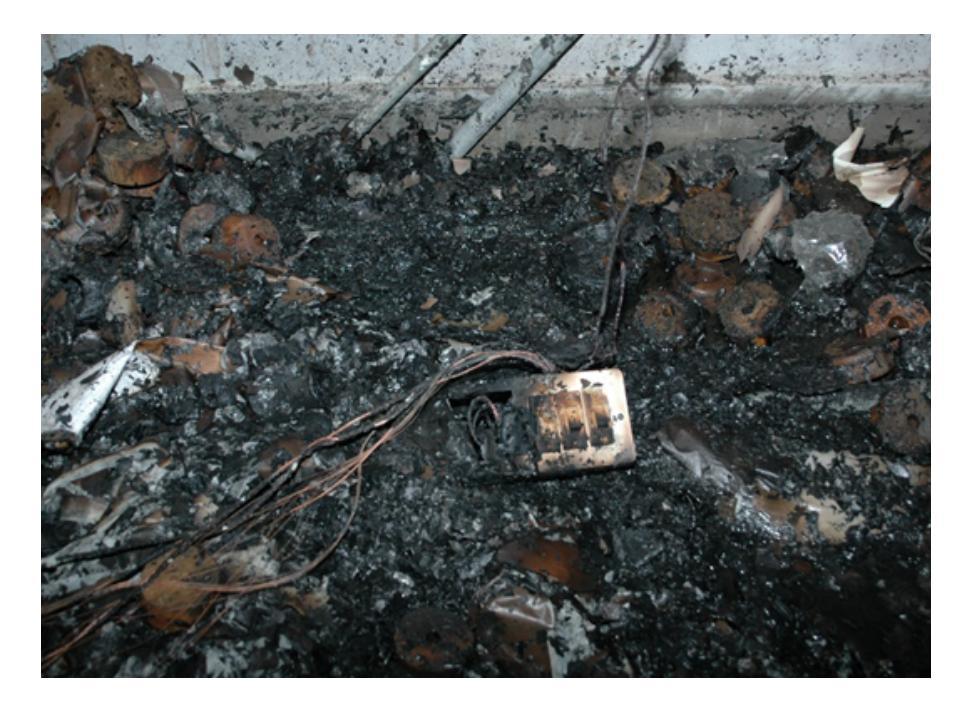
5. Inner electrical circuit of the basement was concealed in the wall in conduit pipes. The effect of high temperature was observed at the left side rear corner of the basement. Partially burnt/charred loose papers were lying on the ground near the heat affected area it was observed after floor was cleaned by workers. (Photograph 4)

Photograph 4: showing the externally mounted wooden extension board at the heat affected corner.

In the present case, on the basis of the observations made at the spot and the condition of the socket of the extension board, cause of fire was detected as electric spark in externally mounted wooden extension board.

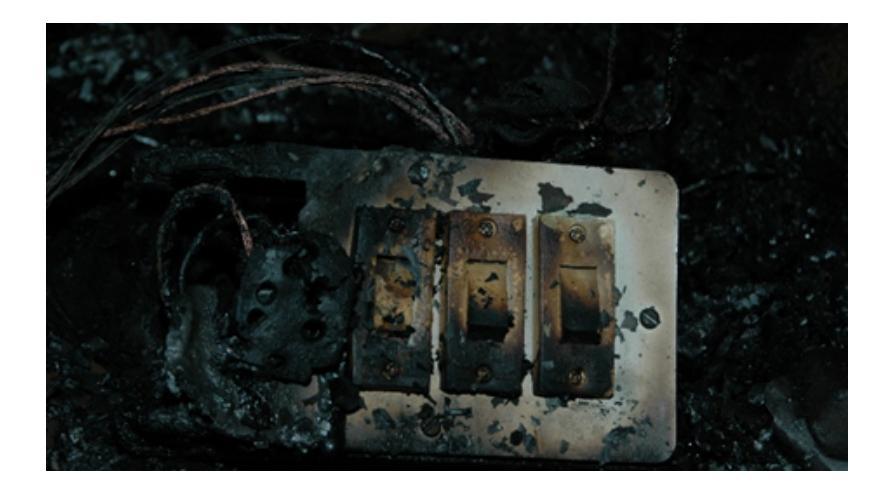
6. The electric circuit of the basement was examined thoroughly and it was observed that one partially burnt/charred wooden extension board (22 cm x 11 cm approx.) with three on/off electric switch and one three pin 5 Amp socket was recovered from the debris of the papers near the heat affected area. This board was used to supply electric current to the two tube lights placed in the wall near the ceiling of the left rear side corner. This board was in addition to the concealed electrical circuit and externally mounted on the masonry pillar near the heat affected area (Photograph 5 (a), (b) and 6 (a)). Heap of loose papers were collected just below this externally mounted board.

Photograph 5(a): Close-up of front side view of the electric circuit board; while in photograph

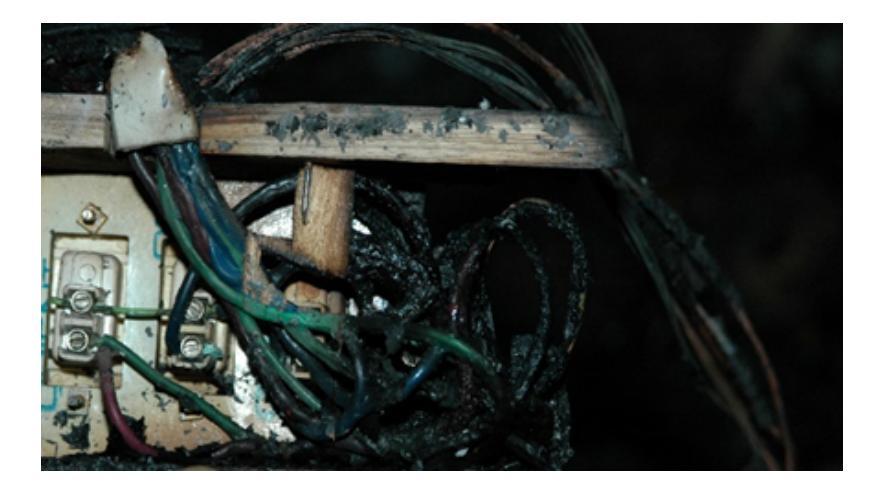
5(b): Close-up inner side view of the electric circuit board and heat affected insulation is shown.

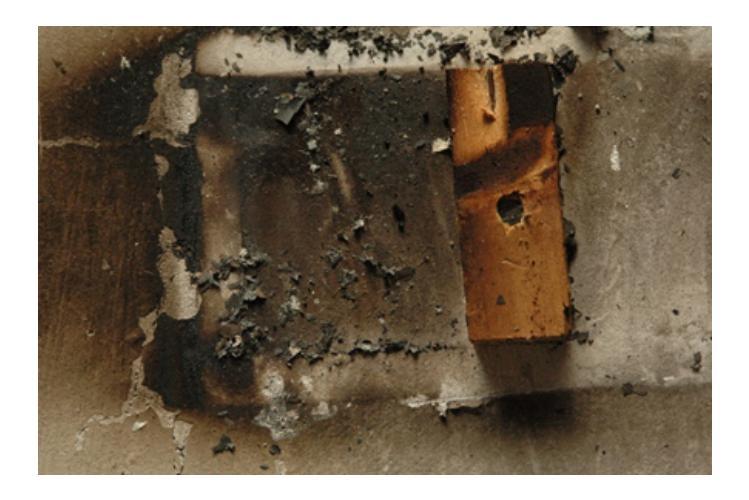
7. The place where the wooden extension board was mounted was identified. Soot was found deposited in the half portion of the board on the wall where the board was.

Mounted. (Photograph 6)

Photograph 6: Showing metallic globules on the wall where the electric circuit board was mounted.

In some cases of fire external heating involve the wire or wiring device as 'victim' of fire and not as the initiator of fire. But some situations do exist where external heating of wiring serves as the initiating event. In many cases, arcing occurs after sufficient overheating. The NFPA921 Guide for Fire and Explosion Investigations 2004, [6] provides photographic examples of wires with parting arcs, but it includes no metallurgical investigation. Aparting arc in this case would have occurred after the fire had started, as the hot, energized wire was pulled apart. The arc was not considered to be the cause of the fire because of its short duration, but it was evidence for flowing current. Careful examination of the insulation tells the truth of internal or external heating of the metallic conductor. Experiment conducted in our laboratory to study the effects of heat on insulation. The insulation around the metallic conductor was examined microscopically and the blistering patters on the PVC insulation were characterised in two categories as external blistering and internal blistering. External blistering appears at the outer surface of the insulation indicate that the temperature is out side of the insulated wire. Internal blistering can be seen at the inner surface which is in contact of the metallic conductor, one of the cause of the pits appears near the metallic conductor is the gases of vapours of the PVC tries to expand but are not able to create enough pressure to escape out of the thick sheet of the insulation in turn cause microscopic pits near the core metallic insulation. Internal blistering was found in the present case. Further, microscopic copper globules also indicate overheating of the copper conductor due to high voltage may be for a fraction of second. Melting of the copper by heating it externally need high temperature i.e 1083 degrees Celsius which can vaporise copper which is practically impossible in ordinary domestic fire incident because the A C Voltage is 220 volt at 50 Hz.
